When a Refractory Failure Isn't!- Some Anchor Issues

Michael C Walton and Paul A Plater
Co-Principals

RefMet

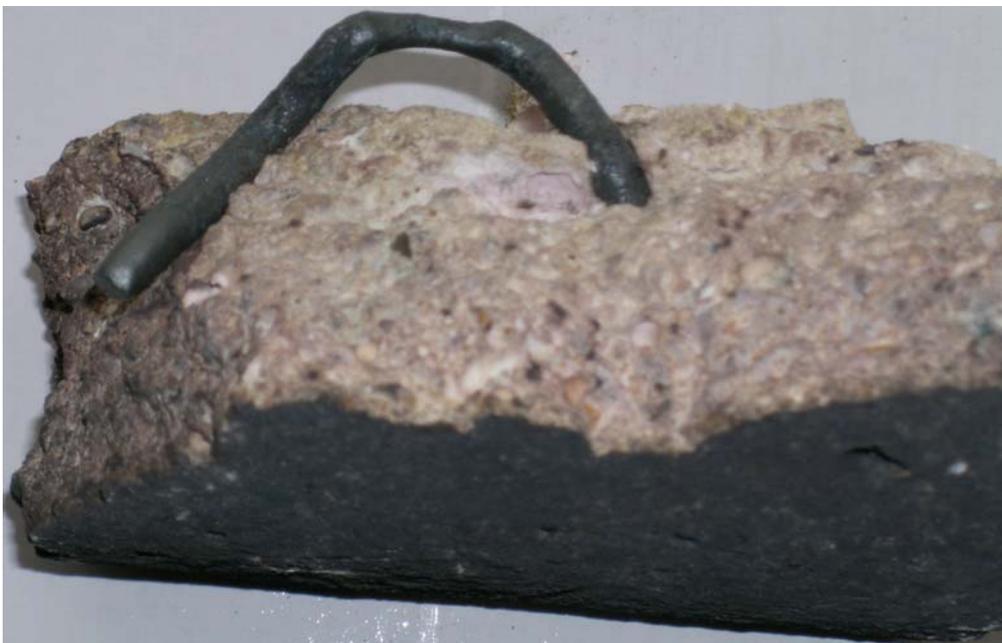
It would be very unusual for a refractory castable to be installed without anchors welded to the shell. It is therefore most important for this activity to be conducted in accordance with accepted standards, especially when affixing stainless/alloy steel materials to mild steel. The most obvious problem leading to failure is lack of weld fusion, that is the weld does not fully bond to the parent metals for a sufficiently strong joint. Figure 1 below shows an example of this. Lack of fusion is caused by unclean surfaces (scale, grease or dirt of the surface(s)); electrodes are too small for welding to a thick shell section; insufficient amperage; incorrect electrode angle and manipulation; and rate of travel is too fast, not allowing proper fusion and heat input.

Figure 1: Refractory with anchor showing partial weld fusion

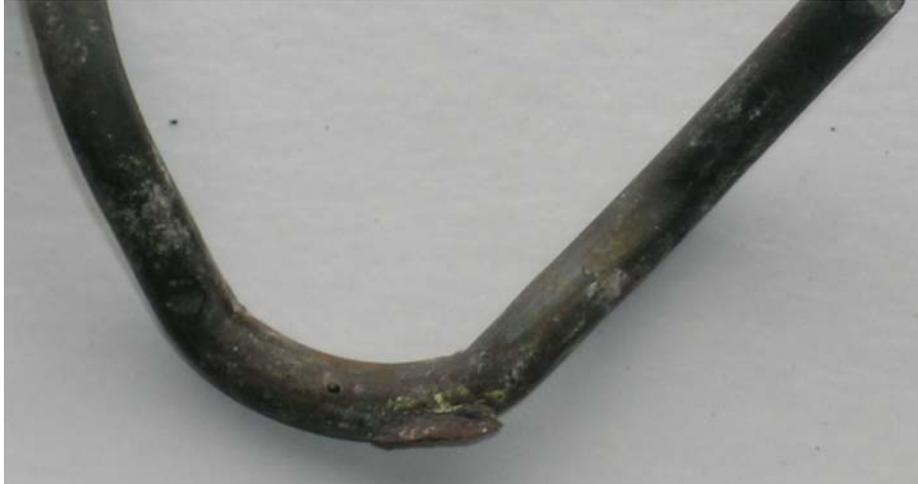
There is also the case when the weld procedure has not been completed; perhaps only the initial positioning tack welding has occurred before the installation of the castable. This is illustrated by Figure 2 below. This can occur due to the number of anchors that need to be secured to the wall and is the result poor production or quality control.

Figure 2: V anchor with tack weld only taken from a “failed” castable system

For this particular circumstance controls should be in place to weld-out each joint fully before installing the next anchor or to have a team of two welders working to first tack weld and then weld out each joint. There will still be a need for each anchor to be visually inspected to ensure it has been fully welded out.
